CASE STUDY

Industry: Steel Industry
Customer: Steel Plant in Germany

OFF-HIGHWAY
POWERTRAIN SERVICES

▶ Handling a complex powertrain is not a problem for Off-Highway Powertrain Services

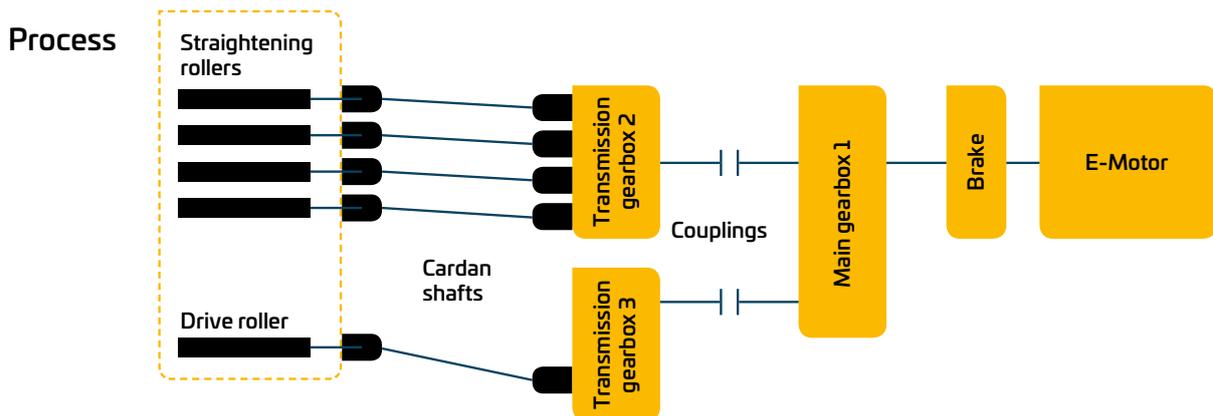
A steel mill customer had a problem with heavy oil leakage from a powertrain gearbox. The customer suspected that the cardan shafts had been incorrectly installed, which could result in powertrain breakdown or cardan shaft failure. Off-Highway Powertrain Services (OHP Services) performed an alignment check to establish if the customer's suspicions were correct.

In fact OHP Services found that the cardan shafts were properly aligned and installed and were not damaged. Instead, a significant mis-alignment was identified in the couplings between the main gearbox and a transmission gearbox (see figure below). OHP Services, as a complete solution provider, reacted immediately on the findings to perform a corrective

alignment procedure on this complex powertrain the very next day. This was a technically difficult alignment since the main gearbox is a fixed, immovable installation. Therefore, the transmission gearbox needed to be adjusted, whilst at the same time it was essential to maintain the cardan shafts in alignment. The customer was also informed that the effect of the thermal growth in the powertrain must be considered to prevent possible misalignment when the powertrain is in normal operation.

One of our specialists monitored the production process during a work shift to check for thermal growth in the powertrain and was able to adjust for this factor during the alignment process.
