CASE STUDY

Industry: Rail Industry
Customer: Rail operator in Israel

OFF-HIGHWAY
POWERTRAIN SERVICES

▶ Off-Highway Powertrain Services solves a systemic problem impeding the customer for past 6 years!

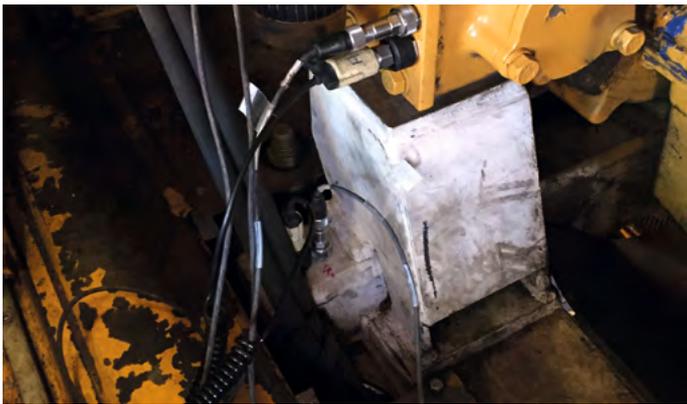
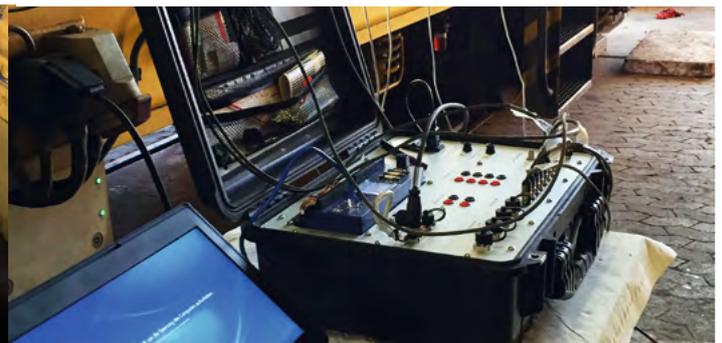
Multi Channel Measurement

A telemetry unit is used for torque measurement on a rotating transmission shaft. The torque telemetry has a rotating element on the shaft that obtains the torque-induced strain from a strain measurement electronic device. The torque signals can be provided to the vehicle control network (e.g. CANBUS) or directly to a data acquisition system (depending on the existing infrastructure and the project requirement).

signals, the torque events, the torque statistics (mean -, max torque, torque amplification factor, load spectrum) and damage indicators (as required and technically possible). To get a more detailed view of the powertrain condition, torque measurement can be combined with other measurement technologies like temperature, vibration and speed sensors.
