Industry: Aircraft
Customer: Airship manufacturer in Germany

► Torque measurement on an airship propulsion

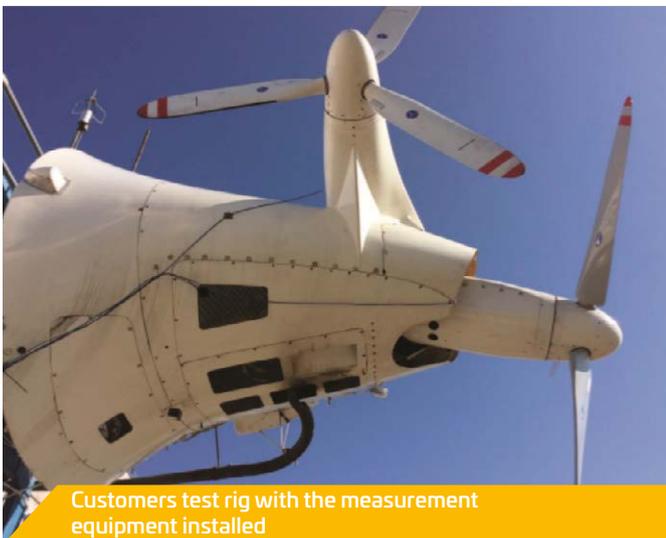
Customers test rig with the measurement equipment installed

For the measurement three different shafts were applied with strain gauges in the OHP Services lab. The telemetry, used to transfer data from the rotating to the non-rotating measurement system, was mounted on site. The measurements were carried out on different operational points that can be associated with different movements of the airship. The preliminary works and the measurements were carried out and monitored by a certified vibration expert of the OHP Services.

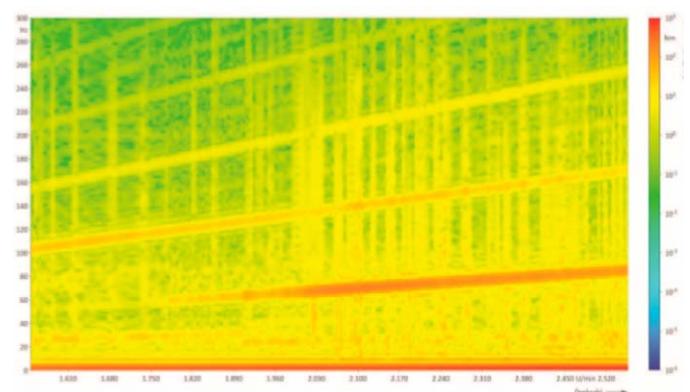
Typical Campbell-Diagram with the excitation of the driving motor

From the measured data Campbell diagrams were calculated for the most relevant operational points. With the Campbell diagram, which shows the Eigen frequencies in relation to the speed, the certified specialist of OHP Services could investigate the resonances of the drive configuration in the different operating points.

The analysis of the data demonstrated that no resonances in the operating points occurred, so they could not be the root cause of the problems. Further investigation of the data showed that two of the three investigated shafts had peak loads caused by the driving motor. The customer was advised to take measures to eliminate the influence of the driving motor. These measures could be performed by OHP Services too.
