# CASE STUDY

**Industry:** Marine  
**Customer:** Energy utility company in Germany

## ▶ Huge time-saving through endoscopy in Marine application

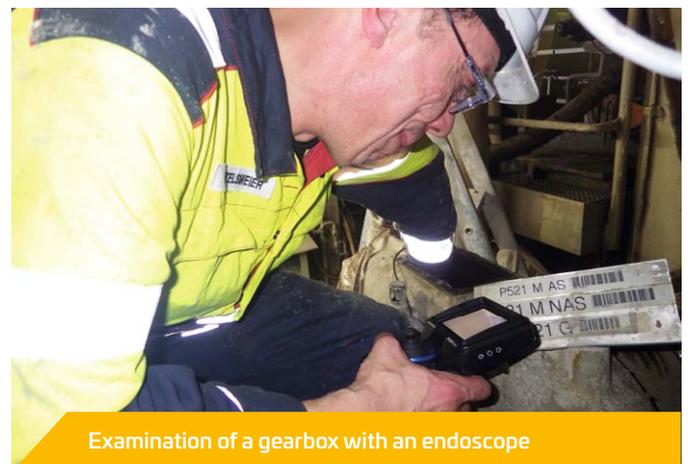
Different technologies such as vibration analysis, thermography and endoscopy were used to determine the root cause of the problem. A small camera with a 3mm lens and a swiveling luminaire head allows clear observation of the powertrain.

Examination of a gearbox with an endoscope
